**REPORT ON THE OCTOBER 18, 2015 INDUSTRIAL FIRE INCIDENT AT  
THE CLOSED STATE OF NEVADA LOW-LEVEL RADIOACTIVE WASTE SITE  
US Highway 95, Near Milepost NY 48  
12 Miles South of Beatty, Nye County, Nevada**

**December 30, 2015**

**State Fire Marshal Division**

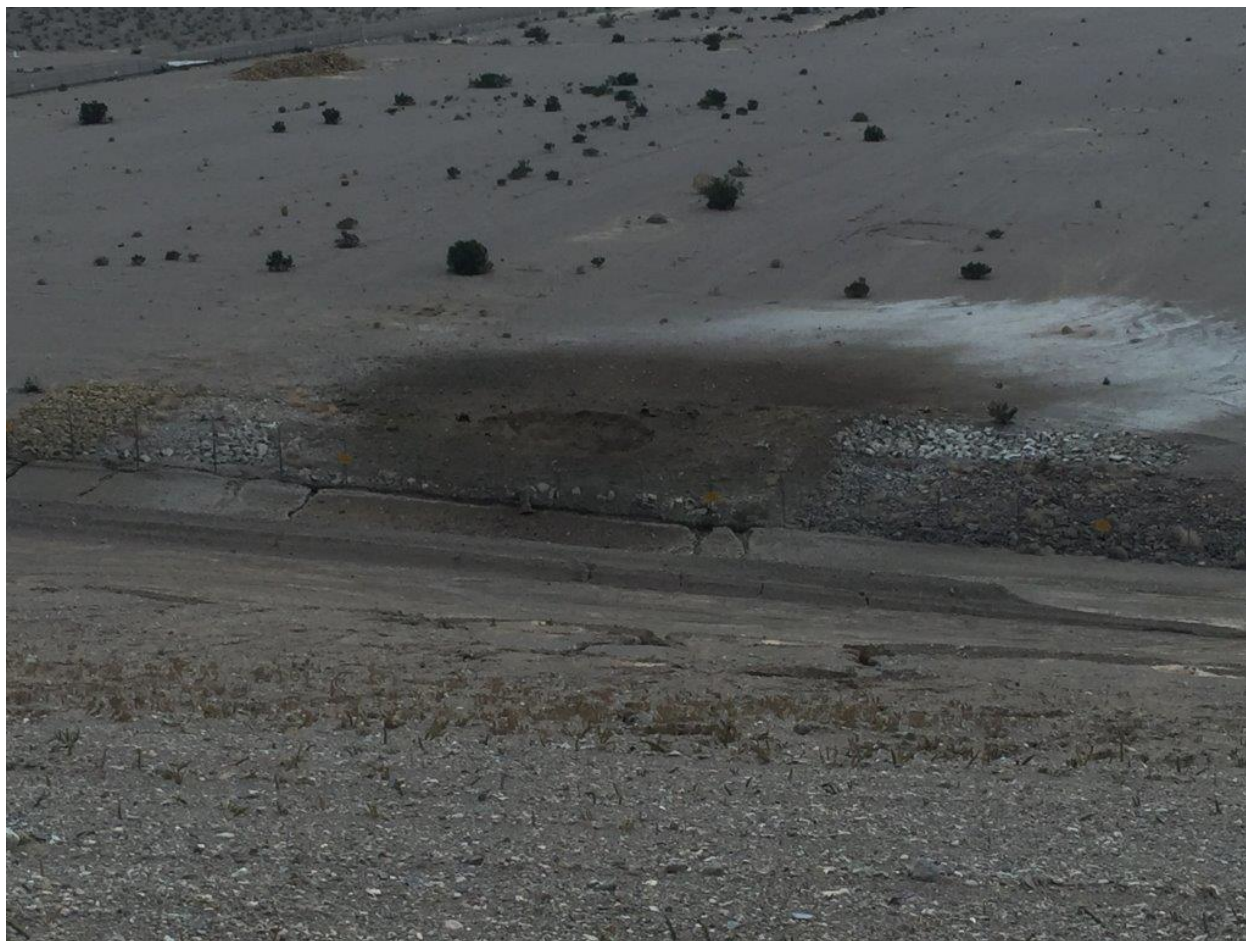
Photo No. 1—View of the incident site looking from the top of the US Ecology site immediately to the east. (SFM photo by Off. Azevedo, October 21, 2015)

At 0900 hours, our team received a safety briefing at the site from the Radiation Control Program Officer and proceeded to the top of Trench 10, to observe an elevated view of the incident area. This was the same location where the video was filmed of the incident when it occurred. Photographs were taken of the incident site. I observed water that had pooled at the site location.

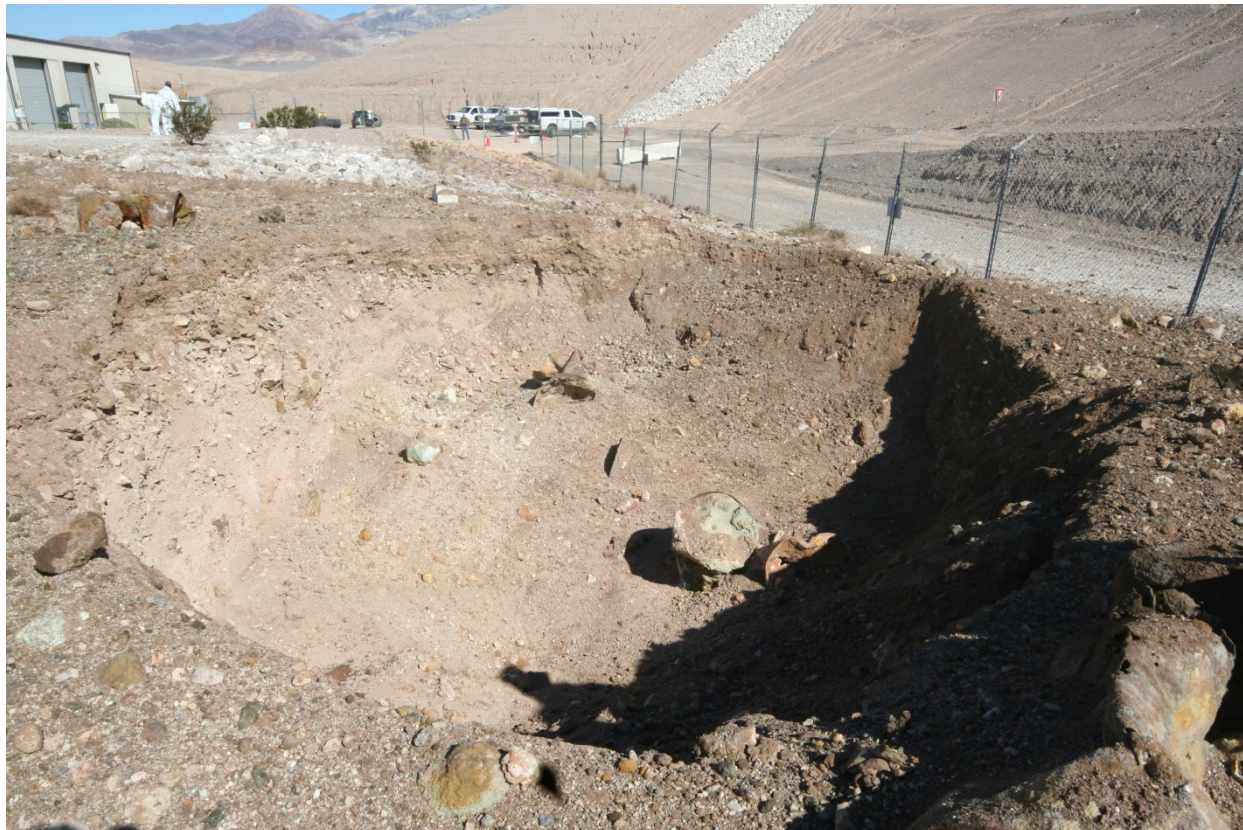
Photo No. 2—Close-up view of the crater area. (SFM photo by Off. Azevedo, October 21, 2015)

We traveled to the area within the fence line. I observed a white material located on the ground. We observed a crater and conducted measurements. The crater measured twenty and one-half (20 1/2) feet by twenty-nine and one-half (29 1/2) feet. I observed approximately five (5) fifty-five (55) gallon drums around the crater. The drums were also corroded with some sustaining more extensive corrosion damage than some others. There was material within the drums that appeared to look similar to the drums that were found on the outside of the fence. I did located material next to the drums that appeared a solid material. The material resembled a chemical salt formed around another material. This was documented with photographs and samples were taken.

I then traveled to the crater. The crater appeared to be approximately seven (7) to nine (9) feet deep. I was unable to determine correct depth of the crater due to the fact that I did not enter into it due to unknown hazards within. I observed four (4) fifty-five (55) gallon drums within the crater. One of the drums I observed appeared to have the same chemical salt type material on the outside of it. The drums within the crater were also heavily corroded and sustained damage. I also continued to observe material in and around the crater area that resembled that same chemical salt type that was observed earlier.

I examined the interior of the crater for evidence of fire. I observed small burn patterns on a drum located within the crater. The burn patterns appeared to be light and left very little discoloration on the drum. I was able to observe some discoloration or very light sooting on one section of the crater. This indicated to me a very clean burning fire. It

also indicated to me that what was burning within the crater may have been some type of chemical material or reactive metal material.

I continued to examine the crater and observed a discoloration line within the crater. It looked like a moisture line where water had seeped into the area and also absorbed into the soil cover material. I also observed what appeared to be puddling at the bottom of the crater. It is my opinion the puddling material was water.

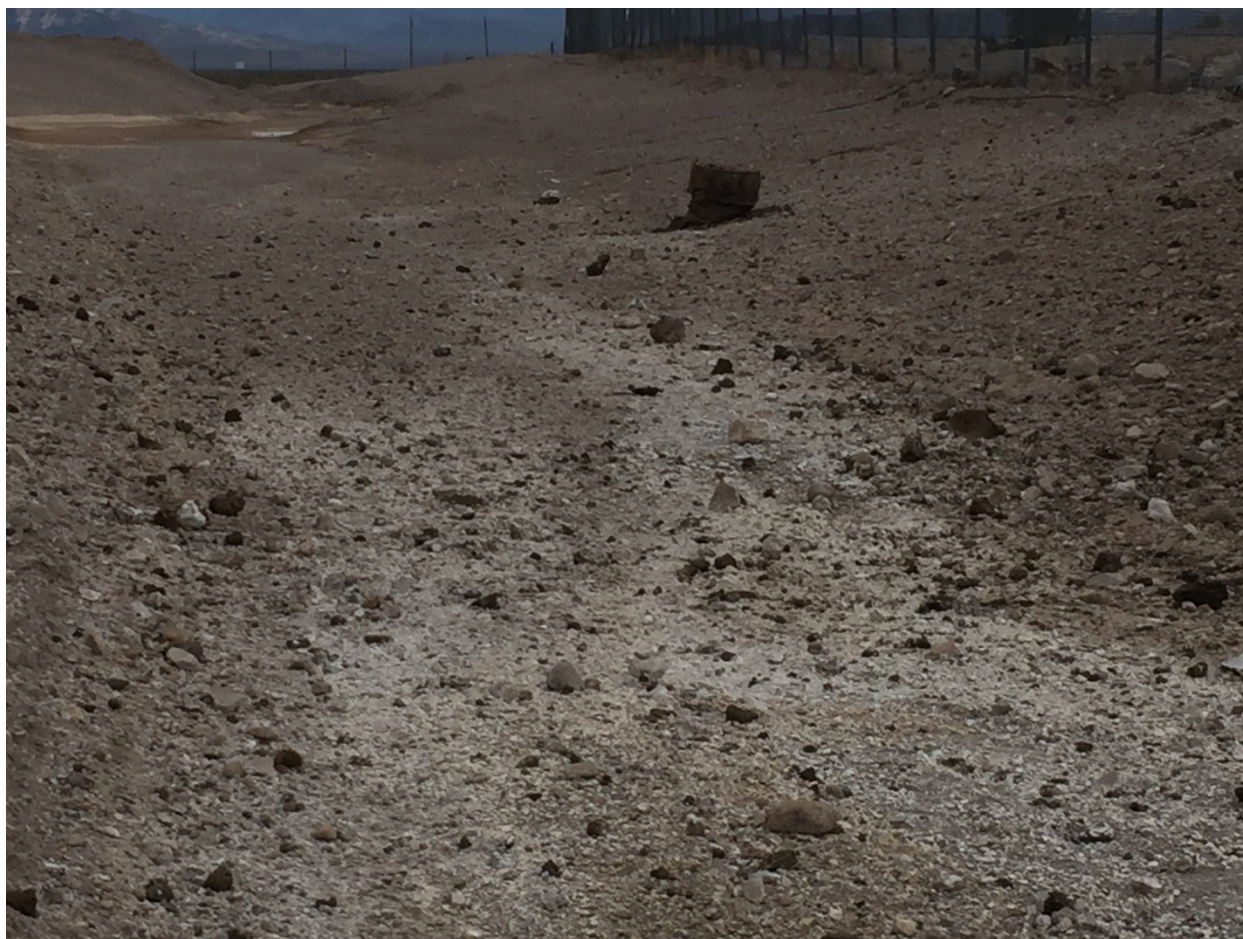
Photo No. 3—View of ejected material and drum on internal site access road outside the low-level radioactive waste area perimeter fence. (SFM photo by Off. Azevedo, October 21, 2015)

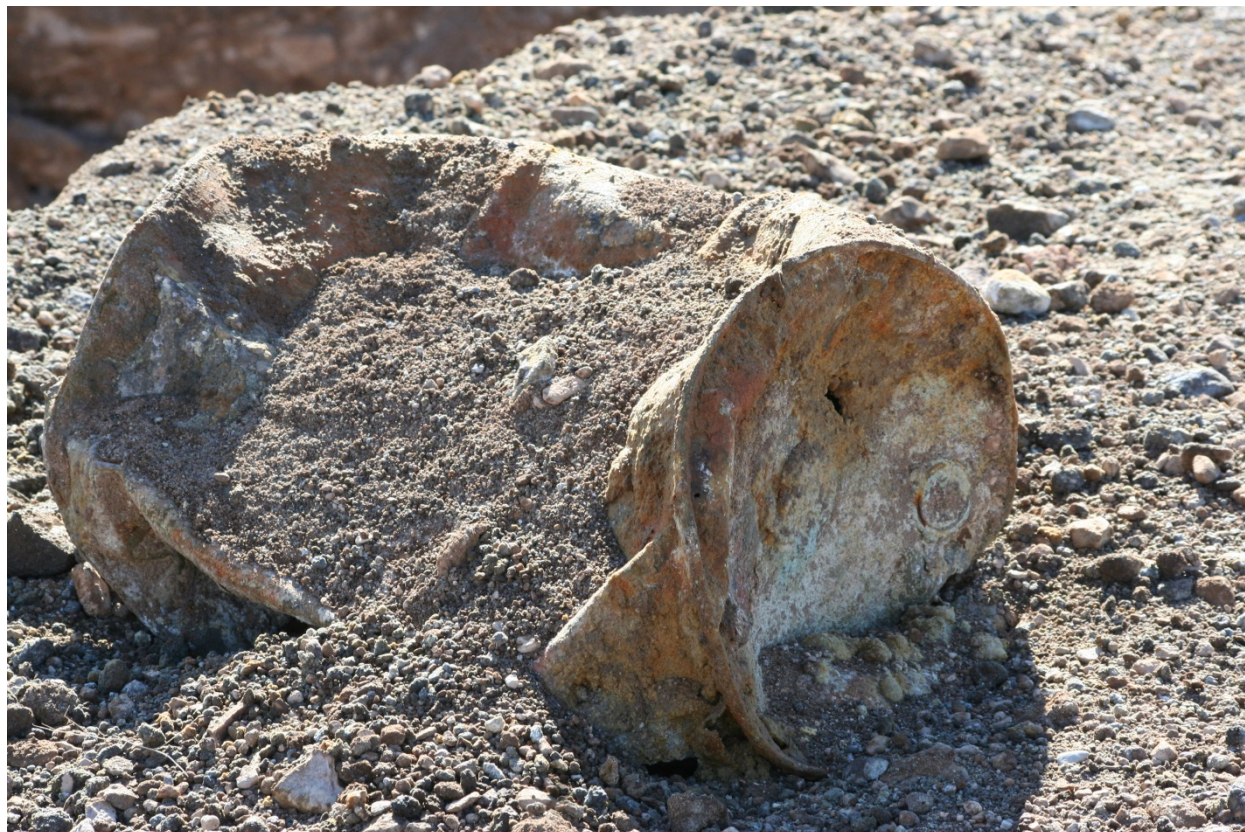
Photo No. 4—Close-up view of drum and ejected material at the rim of the crater. (SFM photo by Off. Azevedo, October 21, 2015)

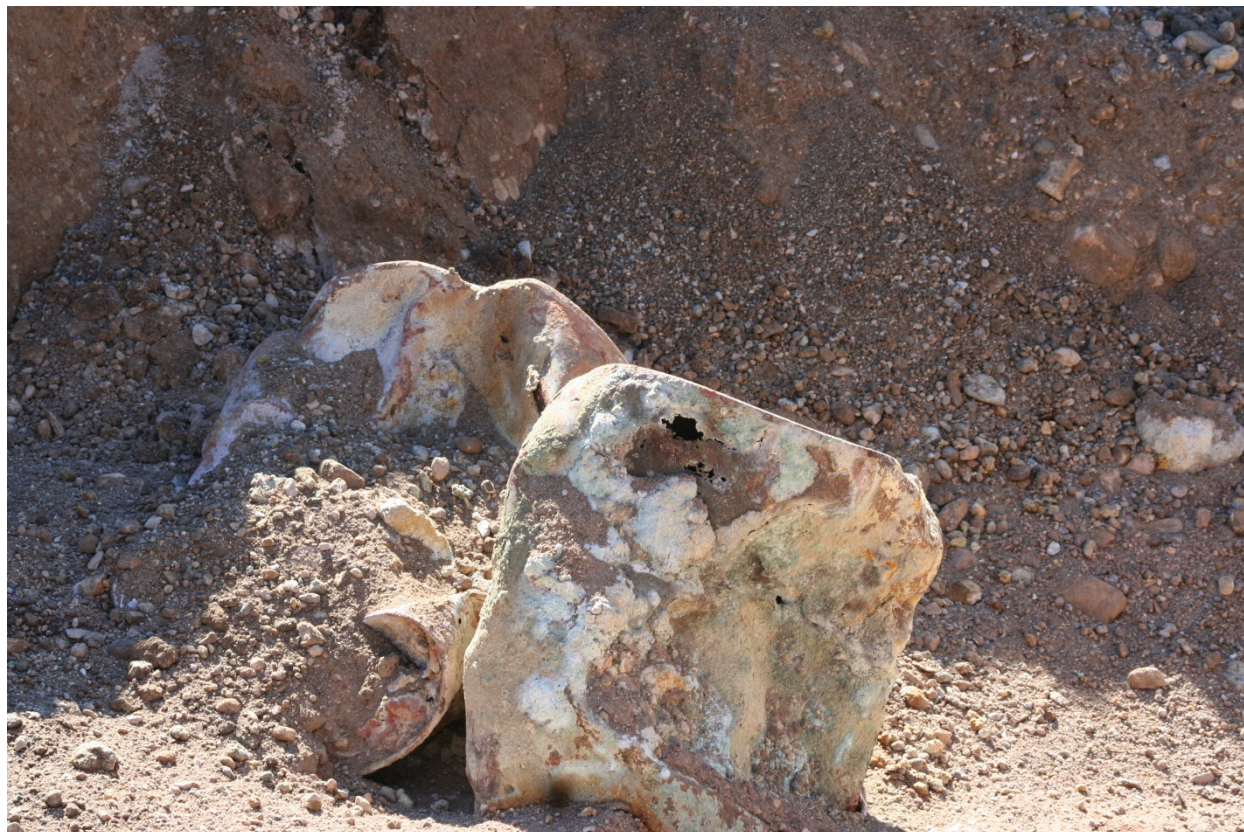
Photo No. 5—Corroded drums with deposited material containing sodium hydroxide.  
(SFM photo by Off. Azevedo, October 21, 2015)

Corrosion of the steel drums containing the metallic sodium over time allowed the packing fluid to drain out leaving the metallic sodium exposed to the underground elements.

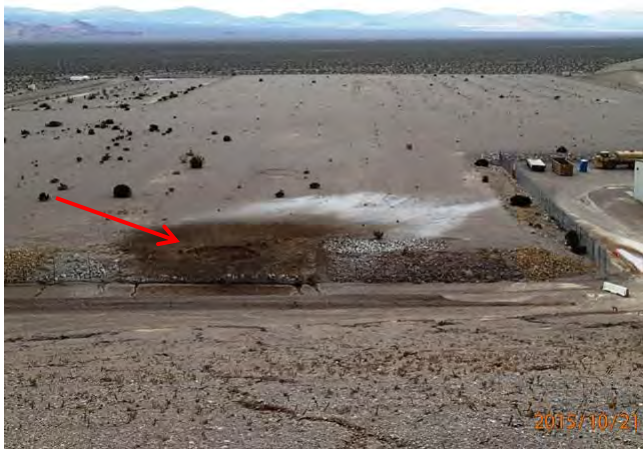
| Ref # | Description | Photograph |
|---|---|---|
| 1 | <p>Overview of the LLRW facility looking west from the top of the adjacent RCRA Trench 11 landfill</p> <p>-Same location from which USEN staff took photos during the fire incident</p> <p>-Incident pit in center of dark brown area. White staining on surface in direction of the prevailing wind during the fire.</p> | |

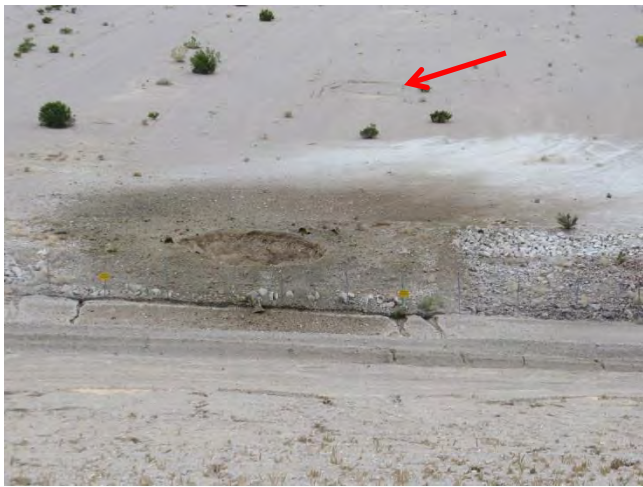
| Ref # | Description | Photograph |
|---|---|---|
| 2 | <p>Closer view of Photo#1</p> <p>-The arrow depicts the location of the discovered opening in the LLRW Trench 14 cover</p> <p>-Yellow signs visible on the security fence at eastern edge of LLRW facility</p> | |

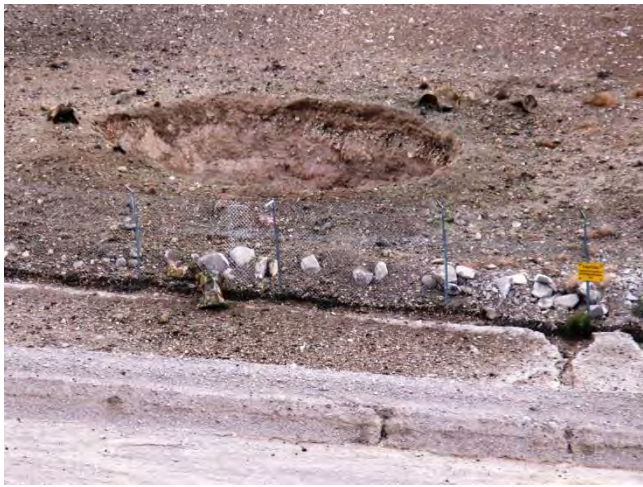
| 3 | <p>Close-up of the incident pit</p> <p>-Note drum on outside of fence and erosion caused by surface runoff</p> | A close-up photograph of a large, circular, eroded pit in the ground. The pit is filled with dark, reddish-brown soil. A chain-link fence runs across the middle of the frame, with a yellow drum or container visible on the outside. The ground around the pit is dry and dusty. |

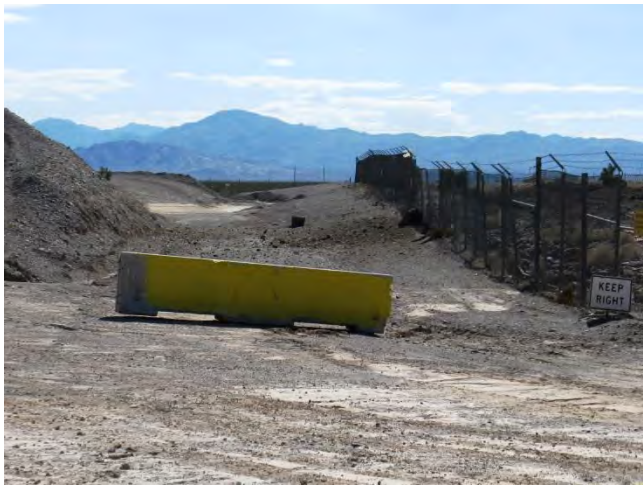
| 4 | <p>View looking south, down the access road to the Maintenance Shop, and along the eastern edge of the LLRW facility.</p> <p>-Note barrier placed to ensure no traffic in the incident area. Similar barrier placed at opposite end of road.</p> | A wide-angle photograph looking down a dirt access road. A large yellow concrete barrier is placed across the road in the foreground. In the background, there is a chain-link fence and a small building. Mountains are visible in the distance under a clear blue sky. |

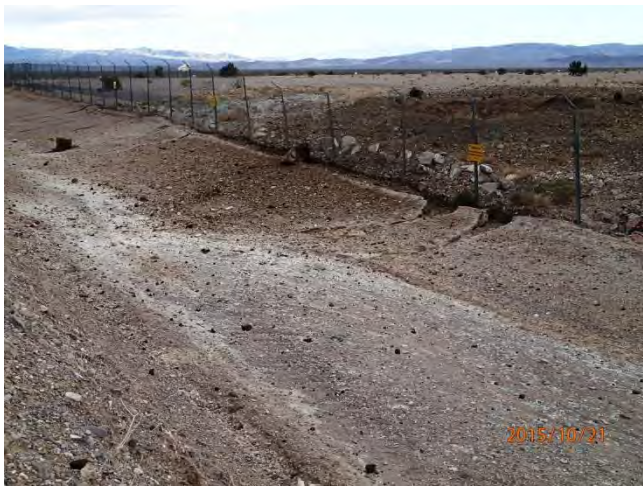
| 5 | <p>View from the access road looking southwest at incident site</p> <p>-Note darker colored debris around the incident pit</p> | A photograph taken from the access road looking southwest towards the incident site. A chain-link fence runs along the right side of the road. In the background, there is a large, dark, eroded pit. The ground is dry and dusty. A date stamp "2015/10/21" is visible in the bottom right corner. |

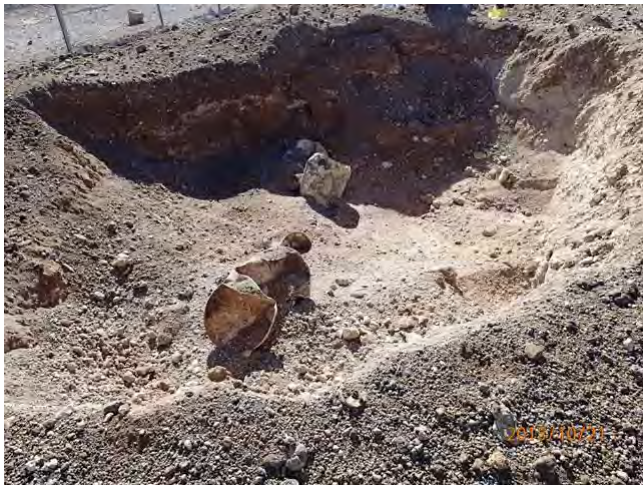
| 6 | View of drums inside the pit/crater resulting from the incident. | |

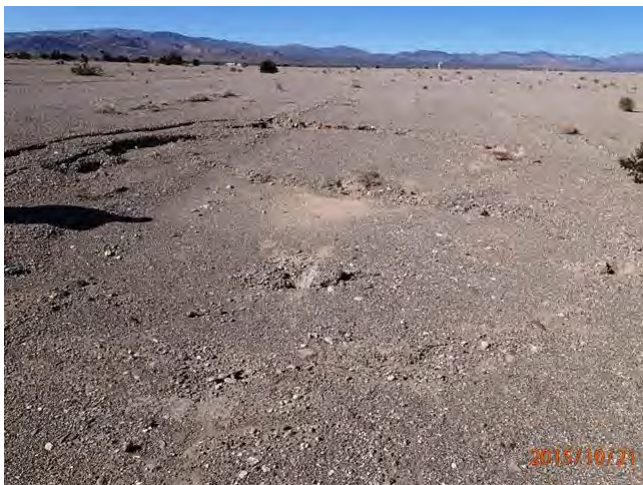
| 7 | View looking west along LLRW Trench 14 at location of the observed cap subsidence and surface cracks. | |

Although the original cover was designed and sloped to drain rainwater, there was evidence to indicate that portions of the cover were compromised due to settling and collapse of underlying waste containers and resulting subsidence and cracking of the cover, allowing the migration of rainwater into these areas.

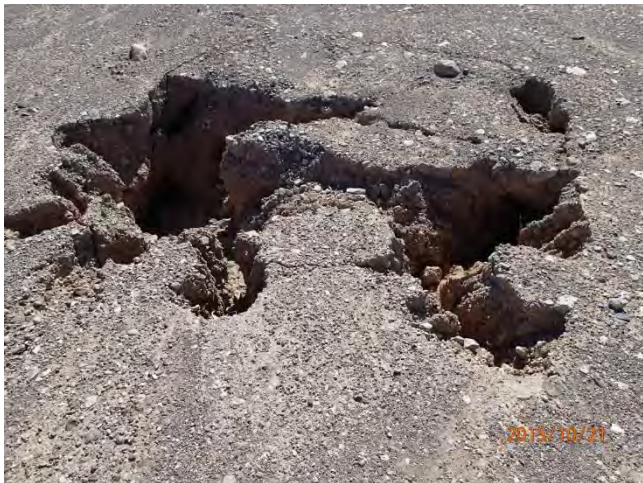
| 9 | View of additional area of surface subsidence and cracking near LLRW Trench 20 | |

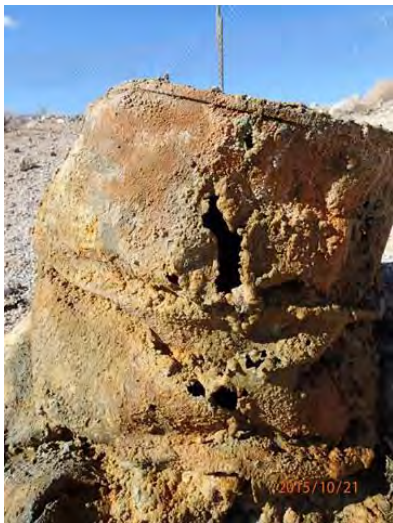
| 11 | <p>View of 55-gallon drum displaced from buried disposal location due to the LLRW incident</p> <p>-Note considerable corrosion to container</p> | |

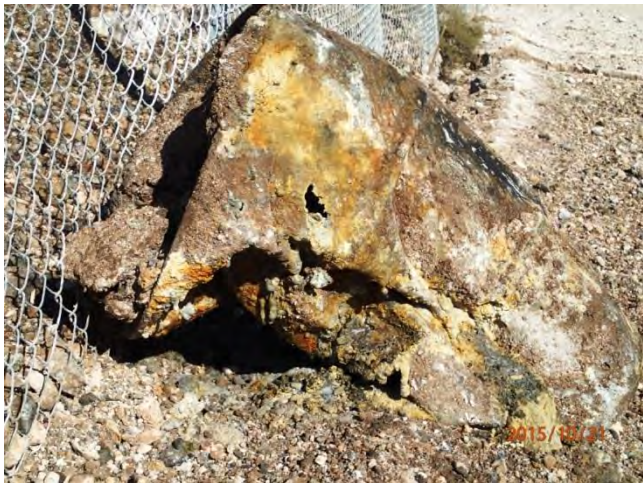
| 12 | <p>View of 55-gallon drum found outside of the LLRW fence boundary</p> <p>-Note again the considerable corrosion of the container</p> | |

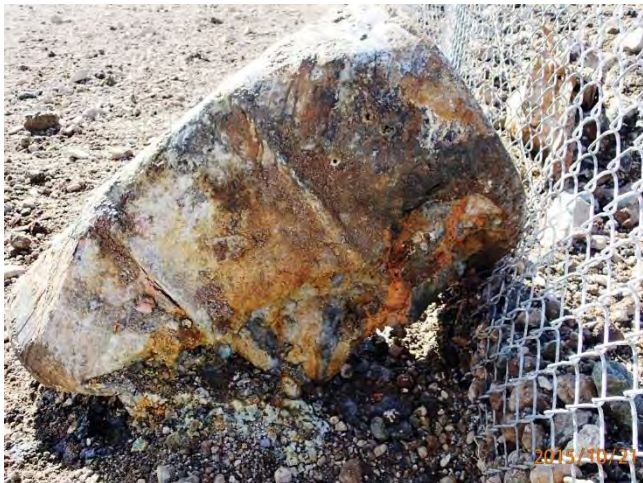
| 13 | <p>View of 55-gallon drum found outside of the LLRW fence boundary</p> <p>-Note considerable corrosion of the container</p> | |

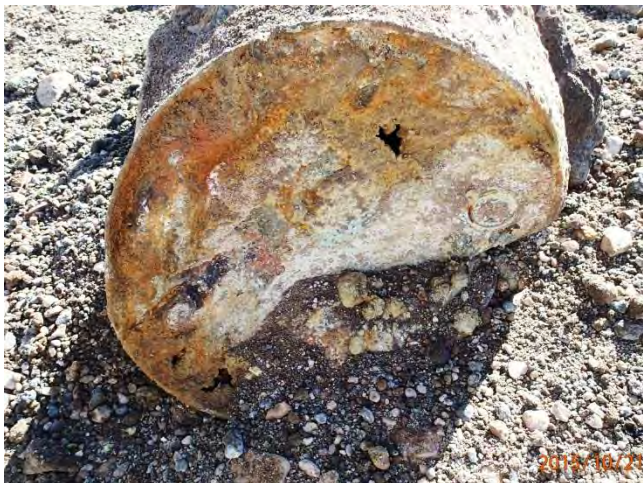
| 14 | <p>View of another 55-gallon drum found displaced from the LLRW disposable trench</p> <p>-Note cap indicating drum was initially intended as liquid container.</p> | |

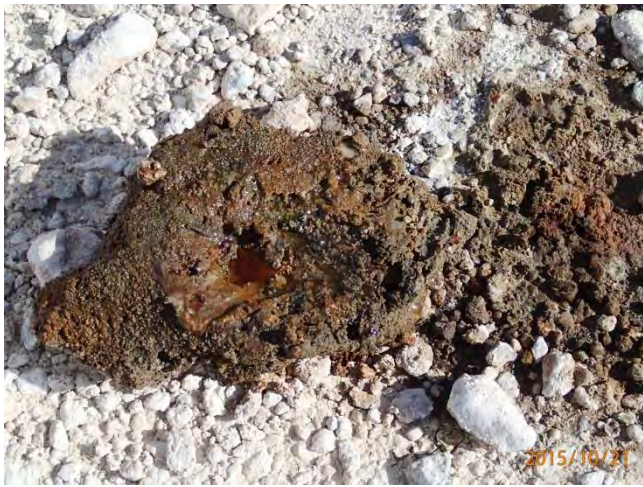
| 15 | <p>View of one example of the displaced debris from the fire incident</p> <p>-Note similar debris found up to 190 feet from the incident location</p> <p>-Note also the wet nature of the debris.</p> | |

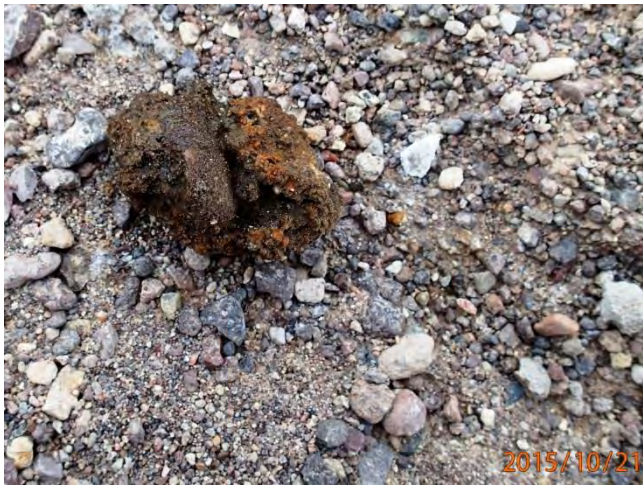
| 16 | <p>Another view of the debris found around the incident pit</p> <p>-Note samples were collected and submitted for lab analysis</p> | |

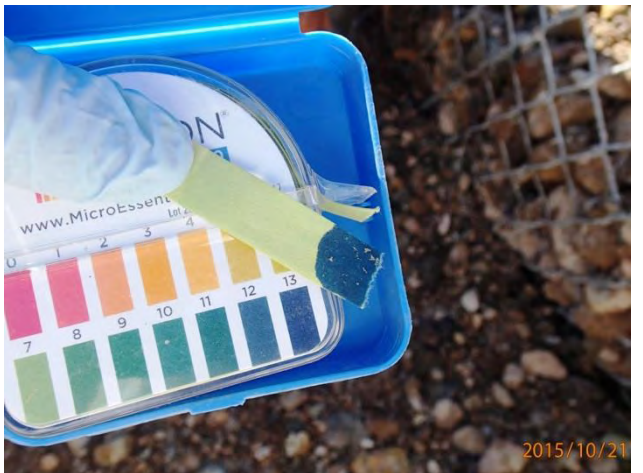
| 17 | <p>View of pH tape wetted by the debris shown in Photo 15.</p> <p>-Note similar result with liquid dripping from one of the displaced drums.</p> | |

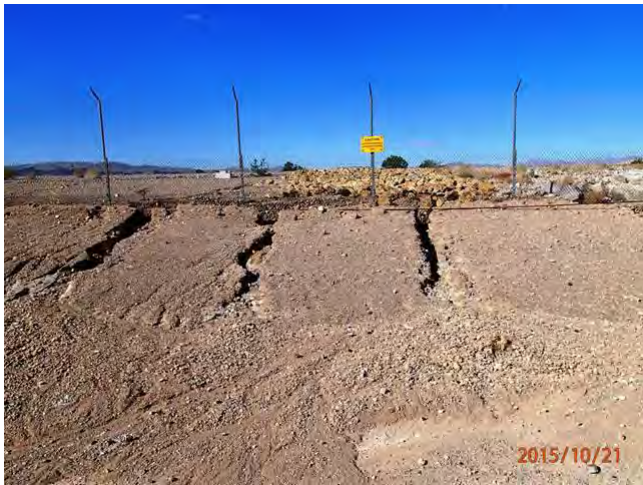
| 18 | <p>View looking west at the eastern edge of LLRW Trench 10</p> <p>-Note the surface erosion indicative of water flow off the east side of the LLRW facility.</p> | A photograph showing a wide, deep erosion gully in the dry, brownish soil of a landfill. In the background, there is a chain-link fence with several vertical posts and a yellow sign. The sky is clear blue. A date stamp "2015/10/21" is visible in the bottom right corner. |

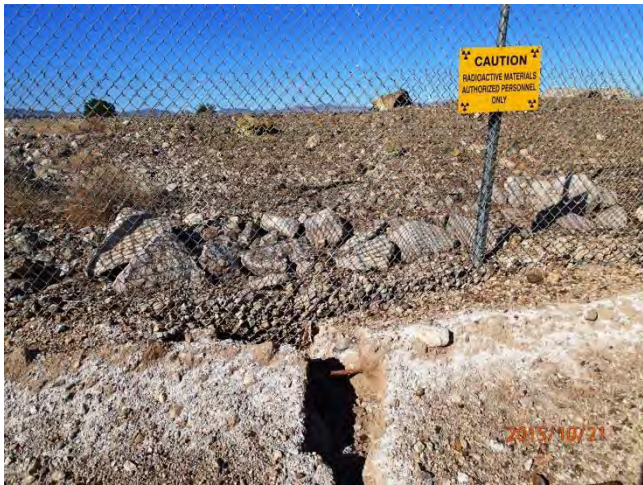
| 19 | <p>Another view of erosion impact due to surface runoff from the LLRW facility.</p> | A photograph showing a close-up of an erosion gully. A chain-link fence is in the foreground, and a yellow sign with the text "CAUTION RADIOACTIVE MATERIALS AUTHORIZED PERSONNEL ONLY" is attached to it. The ground is eroded and shows some debris. A date stamp "2015/10/21" is visible in the bottom right corner. |

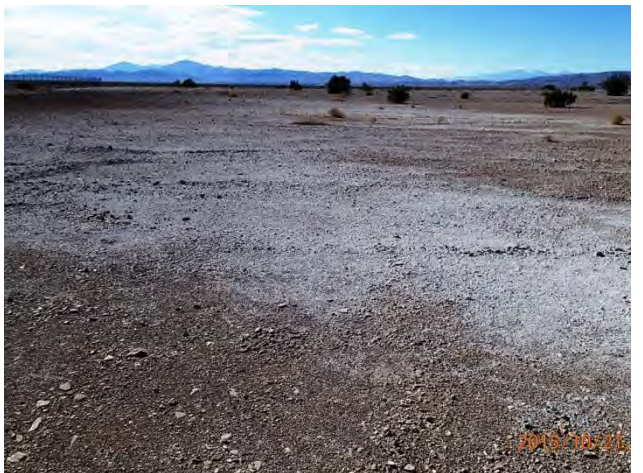
| 20 | <p>View looking south across LLRW cover denoting the white coating deposited on the cap after the fire incident</p> | A wide-angle photograph looking south across a large area of LLRW cover. The ground is covered in a light-colored, silty material, likely the white coating mentioned in the description. The background shows a flat landscape with some distant hills under a blue sky with light clouds. A date stamp "2015/10/21" is visible in the bottom right corner. |
